Aero Plating Works, 1860 North Elston, Chicago, Illinois Closure

Information - EPA I. D. No. ILD005125836

ACES MAINTENANCE is in receipt of the Illinois Environmental Protection Agency's letter dated February 11, 1993, requesting that the closure plan for the 1850-1860 North Elston location in Chicago, Illinois be completely revised. In an effort to comply with the Agency's regulations and guidelines concerning the closure of a hazardous waste storage facility, ACES MAINTENANCE has completed a revised closure plan for review. A copy of the IEPA's letter with closure report references and a RCRA Interim Status Report follows this introduction.

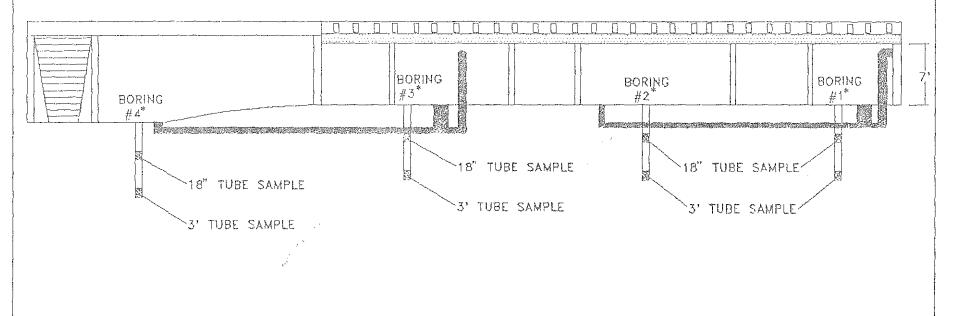
CROSS SECTIONAL VIEW OF BORINGS #1, #2, #3, AND #4 VIEW LOOKING NORTH

ACE'S MAINTENANCE SUBSURFACE INVESTIGATION 12/23/93 NORTH ELSTON AVENUE BORING #1 BORING #2 BORING #3 SHIPPING AND RECEIVING ALLEY BORING #4 SOIL, ROCK, ETC. 1860 NORTH ELSTON AVENUE RIVER WEST BASEMENT 25 JAN 9 JAMES McELROY

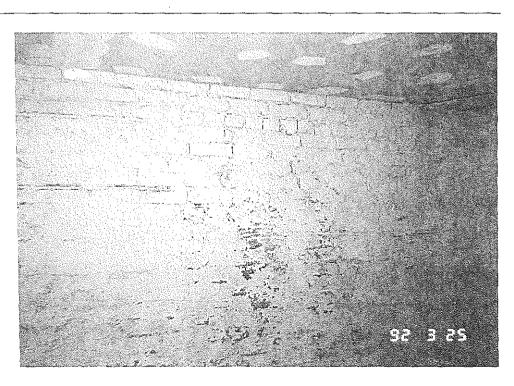
Notes: Close-up of previous picture. Wall deterioration shows presence of Nickel contamination.

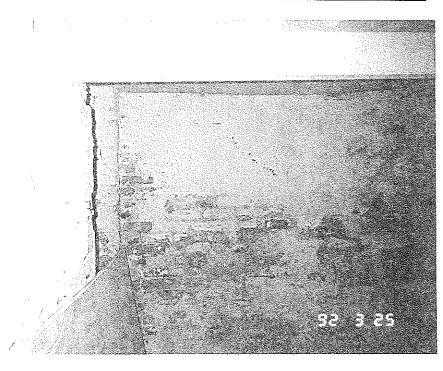
Notes: Decontamination and deterioration of the north wall in the basement of 1860 North Elston prior to clean-up.

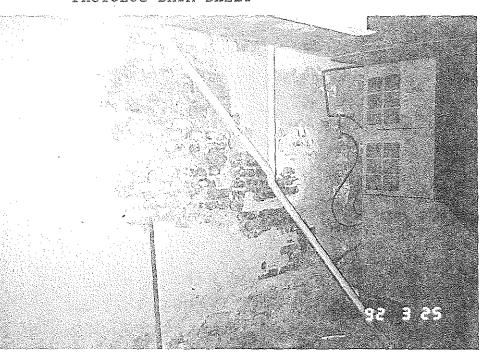
Notes: Wall conditions just east of the previous picture in the basement of 1860 North Elston Avenue.

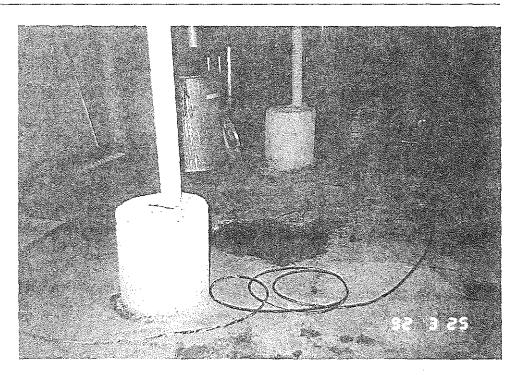
Notes: Clean-up operations. Power washer is shown utilizing the decontamination solution. Walls and floors were scrubbed and power washed to rinse contaminants off the surfaces.

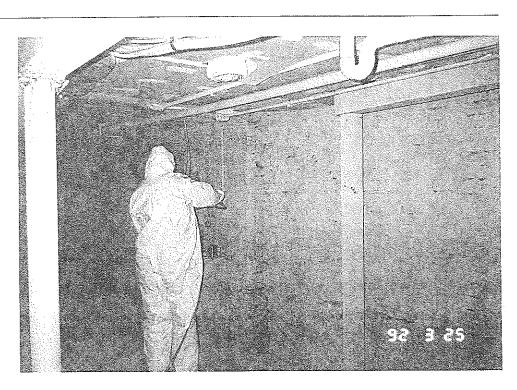
Notes: Worker is using the power sprayer and decontamination solution to clean the south wall of 1860 North Elston Avenue's basement.

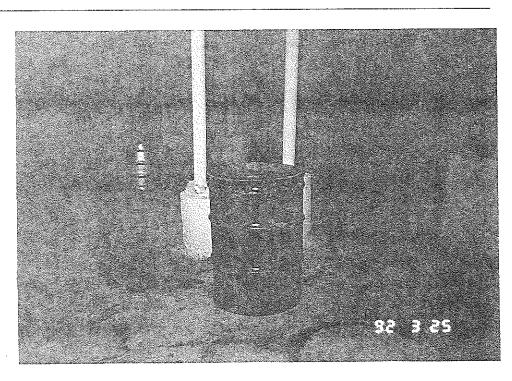
Notes: Hazardous waste waters produced were temporarily stored in this 55 gallon drum.

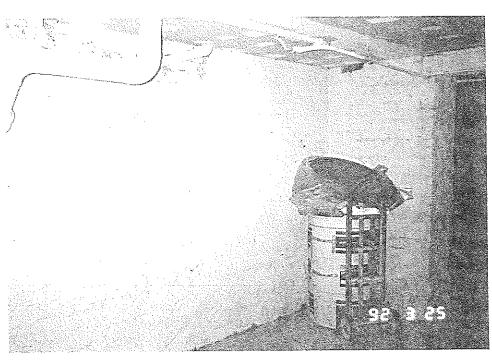
Notes: Solid hazardous wastes produced during clean-up operations were transported in a plastic 55 gallon drum.

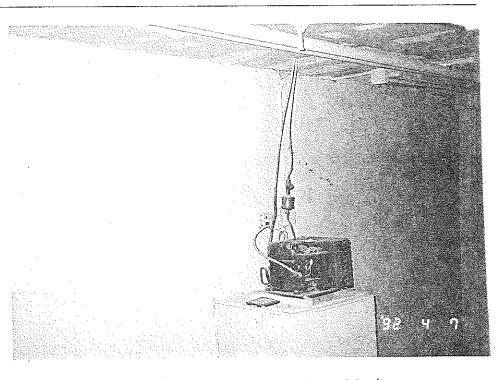
Notes: Decontamination and sealing of the south wall in the basement of 1860 North Elston Avenue.

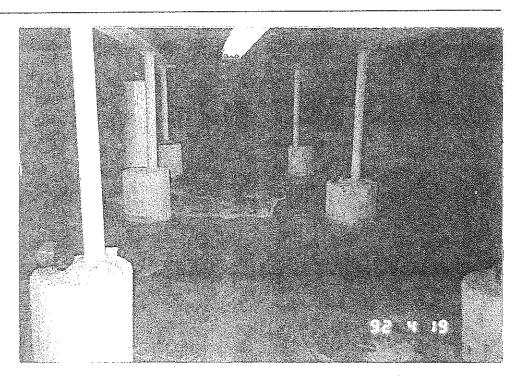
Notes: Additional view of the new concrete floor in the basement of 1860 North Elston Avenue.

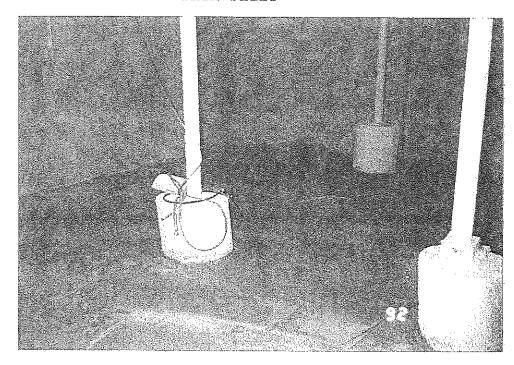
Notes: Close-up view in the northeast corner of the concrete flooring laid in the basement of 1860 North Elston Avenue.

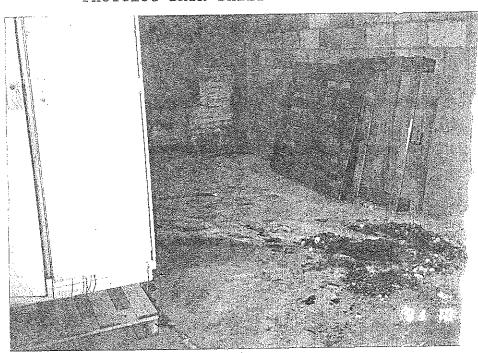
Notes: First boring drilled in the southwest corner of 1850 North Elston Avenue where Aero Plating previously stored hazardous waste.

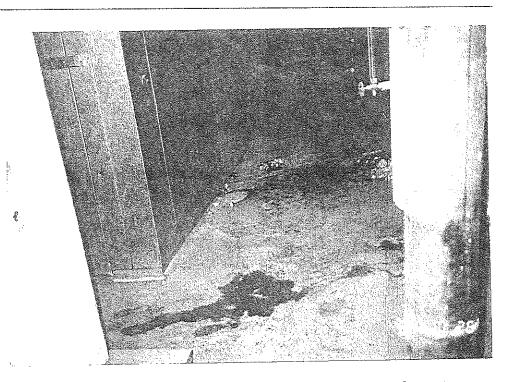
Notes: Second boring drilled in the southwest corner of 1850 North Elston Avenue where Aero Plating previously stored hazardous waste.

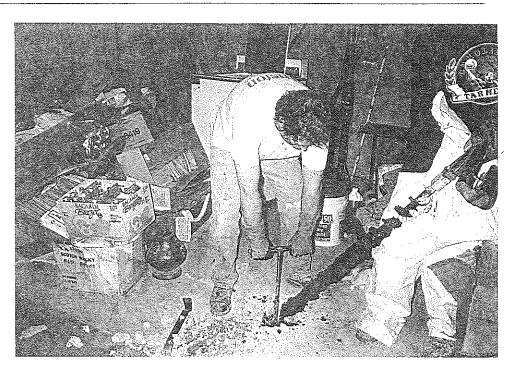
Notes: Shelby tube sampling at Boring #3 in the west central section of 1860 North Elston Avenue's basement. Copper line pictured behind worker pumps basement drain water up from the sump pit to the public sewer lines located under Cortland Avenue.

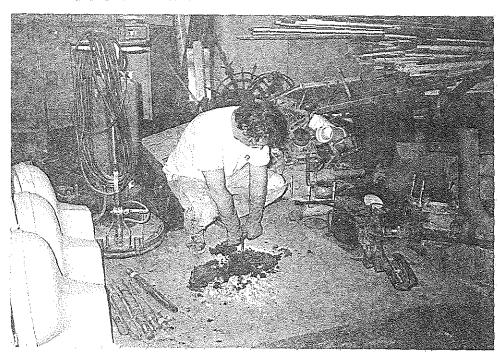
Project:
Aero Plating
Company
Location:
1850-1860
North Elston
Photo #:
25

Notes: Shelby tube sampling at Boring #4 in the western section of 1860 North Elston Avenue's basement.

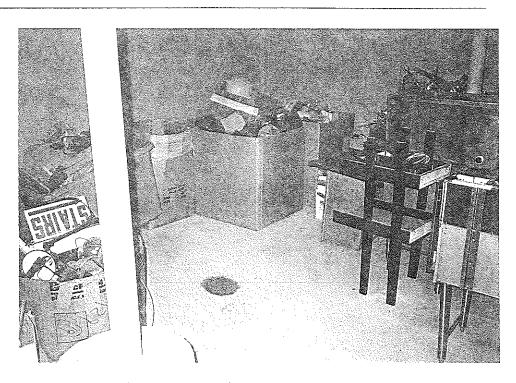
Notes: Location of Boring #1 located in the northeast section of 1860 North Elston Avenue's basement. Troweled cement finish is shown of where drilling operations took place.

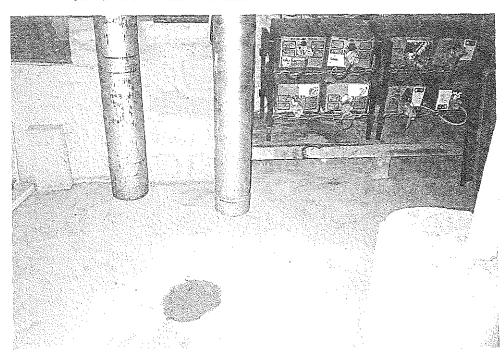
Project:
Aero Plating
Company
Location:
1850-1860
North Elston
Photo #:
29

Notes: Troweled cement finish for Boring #2 in the east central section of 1860 North Elston Avenue's basement. Refer to picture #1 for drilling operations.

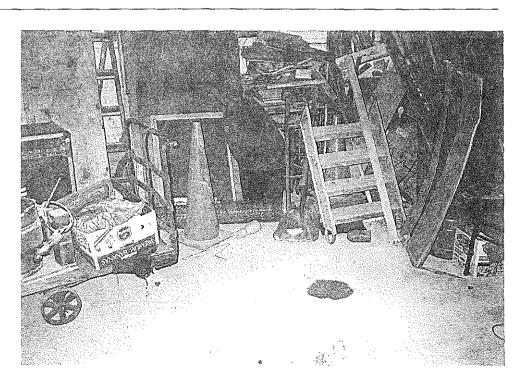
Notes: Troweled cement finish for Boring #5 in the northeast section of 1850 North Elston Avenue. Refer to picture #5 for drilling operations.

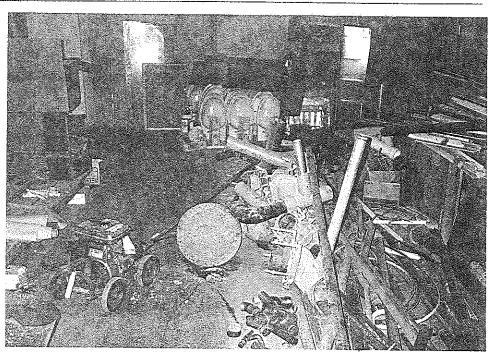
Notes: River West's west basement storage area. Pictured here is the drain that flows east into the west sump pit. Newly poured concrete flooring by ACES Maintenance during closure operations show no evidence of cracking.

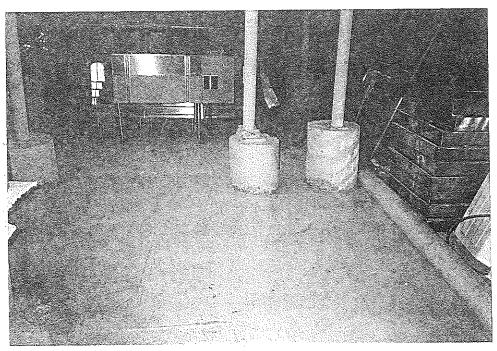
Notes: River West's east basement area showing the new concrete floor laid after closure operations. No cracks exist in this area. The east sump pit is positioned behind the stainless steel objects where the copper line pumps water to the public sewer line under Elston Avenue. The copper line can be better seen in photograph # 45.

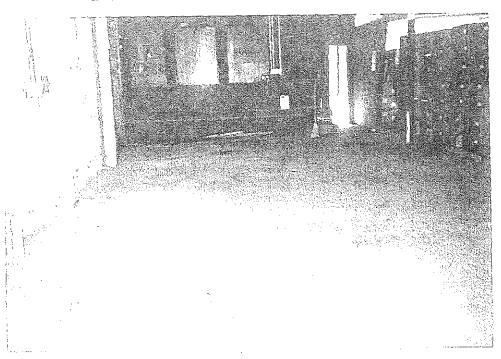
Project:
Aero Plating
Company
Location:
1850-1860
North Elston
Photo #:
60

Notes: Flooring just north of the hazardous waste storage area.

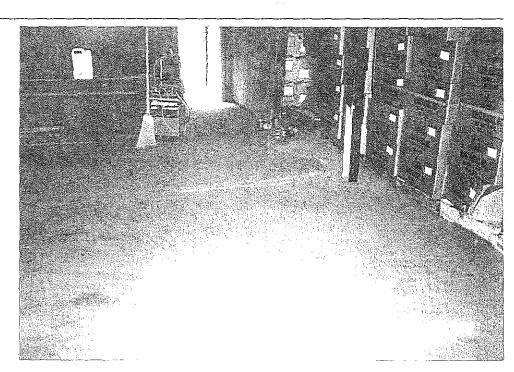
Notes: Close-up view farther west of the previous picture.
